Manhole Inspection Summary

Manhole # S23GG1018MH

Insp Date: **12/11/06 12:55 PM**

Location Address: **1315 42ND ST**

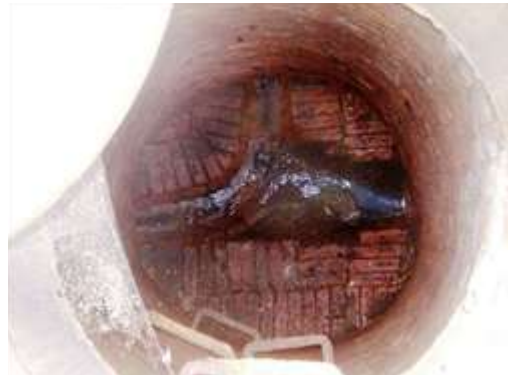
Top View

Condition: ☐ Sound ☐ Cracked ☒ **Root Intrusion** ☒ **Deteriorated** ☐ Leaks ☒ **Debris**

Steps Count: **4** Missing: **0** ☒ **Corroded**

Corroded steps. Channel debris.

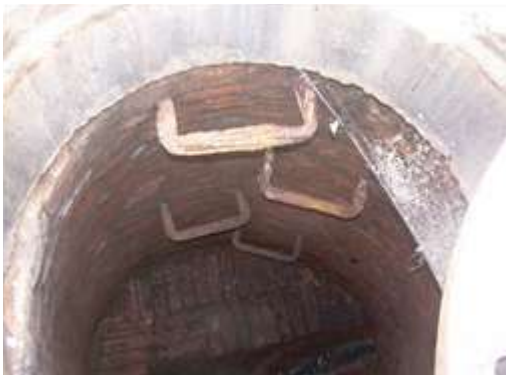
Defect

Frame Offset: **2** (in.) Condition: ☐ Sound ☐ Cracked ☒ **Leaks**

Infiltration: ☐ None ☒ **Joint** ☐ Cracks ☒ **Mortar** ☐ Roots ☐ Wall

Frame leaks. Adjustment infiltration - other side.

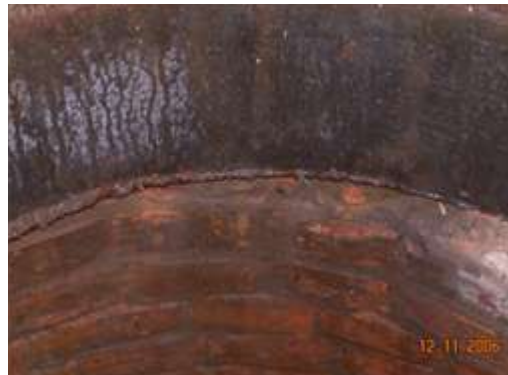
Defect

Frame leaks. Frame offset. Adjustment infiltration.

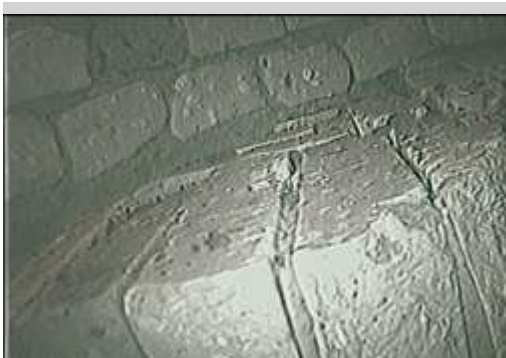
Defect

Condition: ☐ Sound ☐ Cracked ☐ Root Intrusion ☒ **Deteriorated** ☐ Leaks ☐ Debris

Bench deterioration (missing mortar).

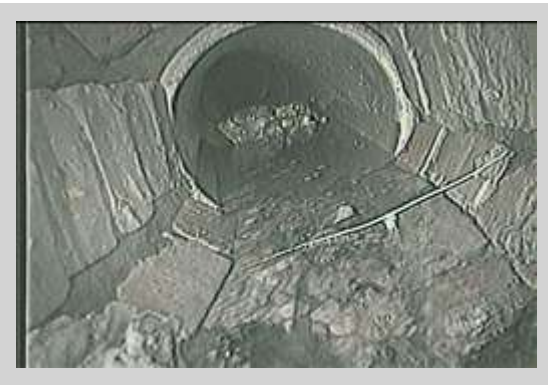
8 in. Circular Gravity Sewer Pipe Out @ 12 O'Clock

Channel deterioration and root intrusion.

Deposits: ☐ None ☐ Mud ☐ Sludge ☒ **Debris** ☐ Grease

Silt Depth: **0** (in.) Deposits Extent: **Light**

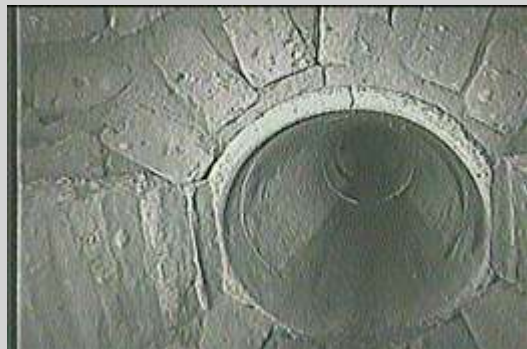
Pipe In @ 9 O'Clock

Pipe Seal Cond: **Cracked**
